ACTIVITY REPORT RE: AIR QUALITY MONITORING

MACHINE STATUS OF JOHN HAY MANAGEMENT

**CORPORATION (JHMC)**

METONE E-BAM PLUS

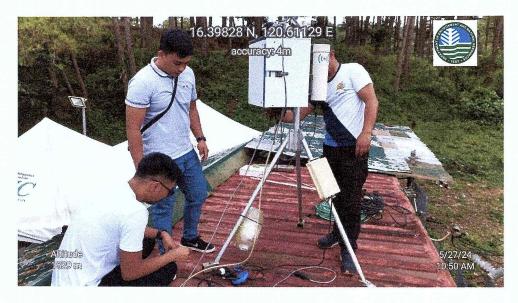
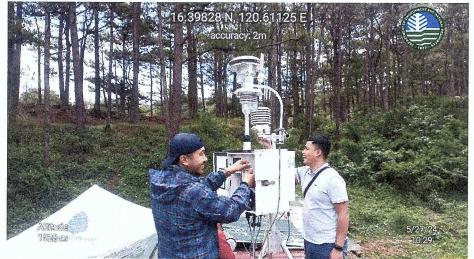
- The equipment shows "Hardware Failure" message after Self-Test, and the equipment will not push through with the self-test (flow check) of the equipment but according to Mr. Christopher Haban of JHMC, who accompanied the EMB-CAR Personnel, the air quality monitoring equipment can run for a few hours but will stop midway through the sampling process and will <u>not</u> resume its air quality sampling, thus not complying with the 75% capture rate as required in DMC 2005-13.
- After the machine stopped, it will show "Sensor Range" error message on the screen, then the cycle will repeat.

- The EMB-CAR personnel conducted leak testing of the equipment for internal and external component, and no leaks were found.
- The EMB-CAR Personnel tried plugging their BX-597 sensors to the equipment of the E-BAM Plus of the CJH to the EBAM Plus unit but to no avail. The error still arises.
- The team tried plugging their own vacuum pump to the unit of the CJH but still shows the errors.
- The team did basic troubleshooting and was not successful.
- It was recommended to contact third party contractors as this error was beyond the capability and knowledge of the team.
- Furnish JHMC a copy of this report.
