REHABILITATION OF THE MAIN STRUCTURE

JOHN HAY MANAGEMENT CORPORATION

PROJECT TITLE  
**REHABILITATION OF THE VOA  
LOGHOME 3**

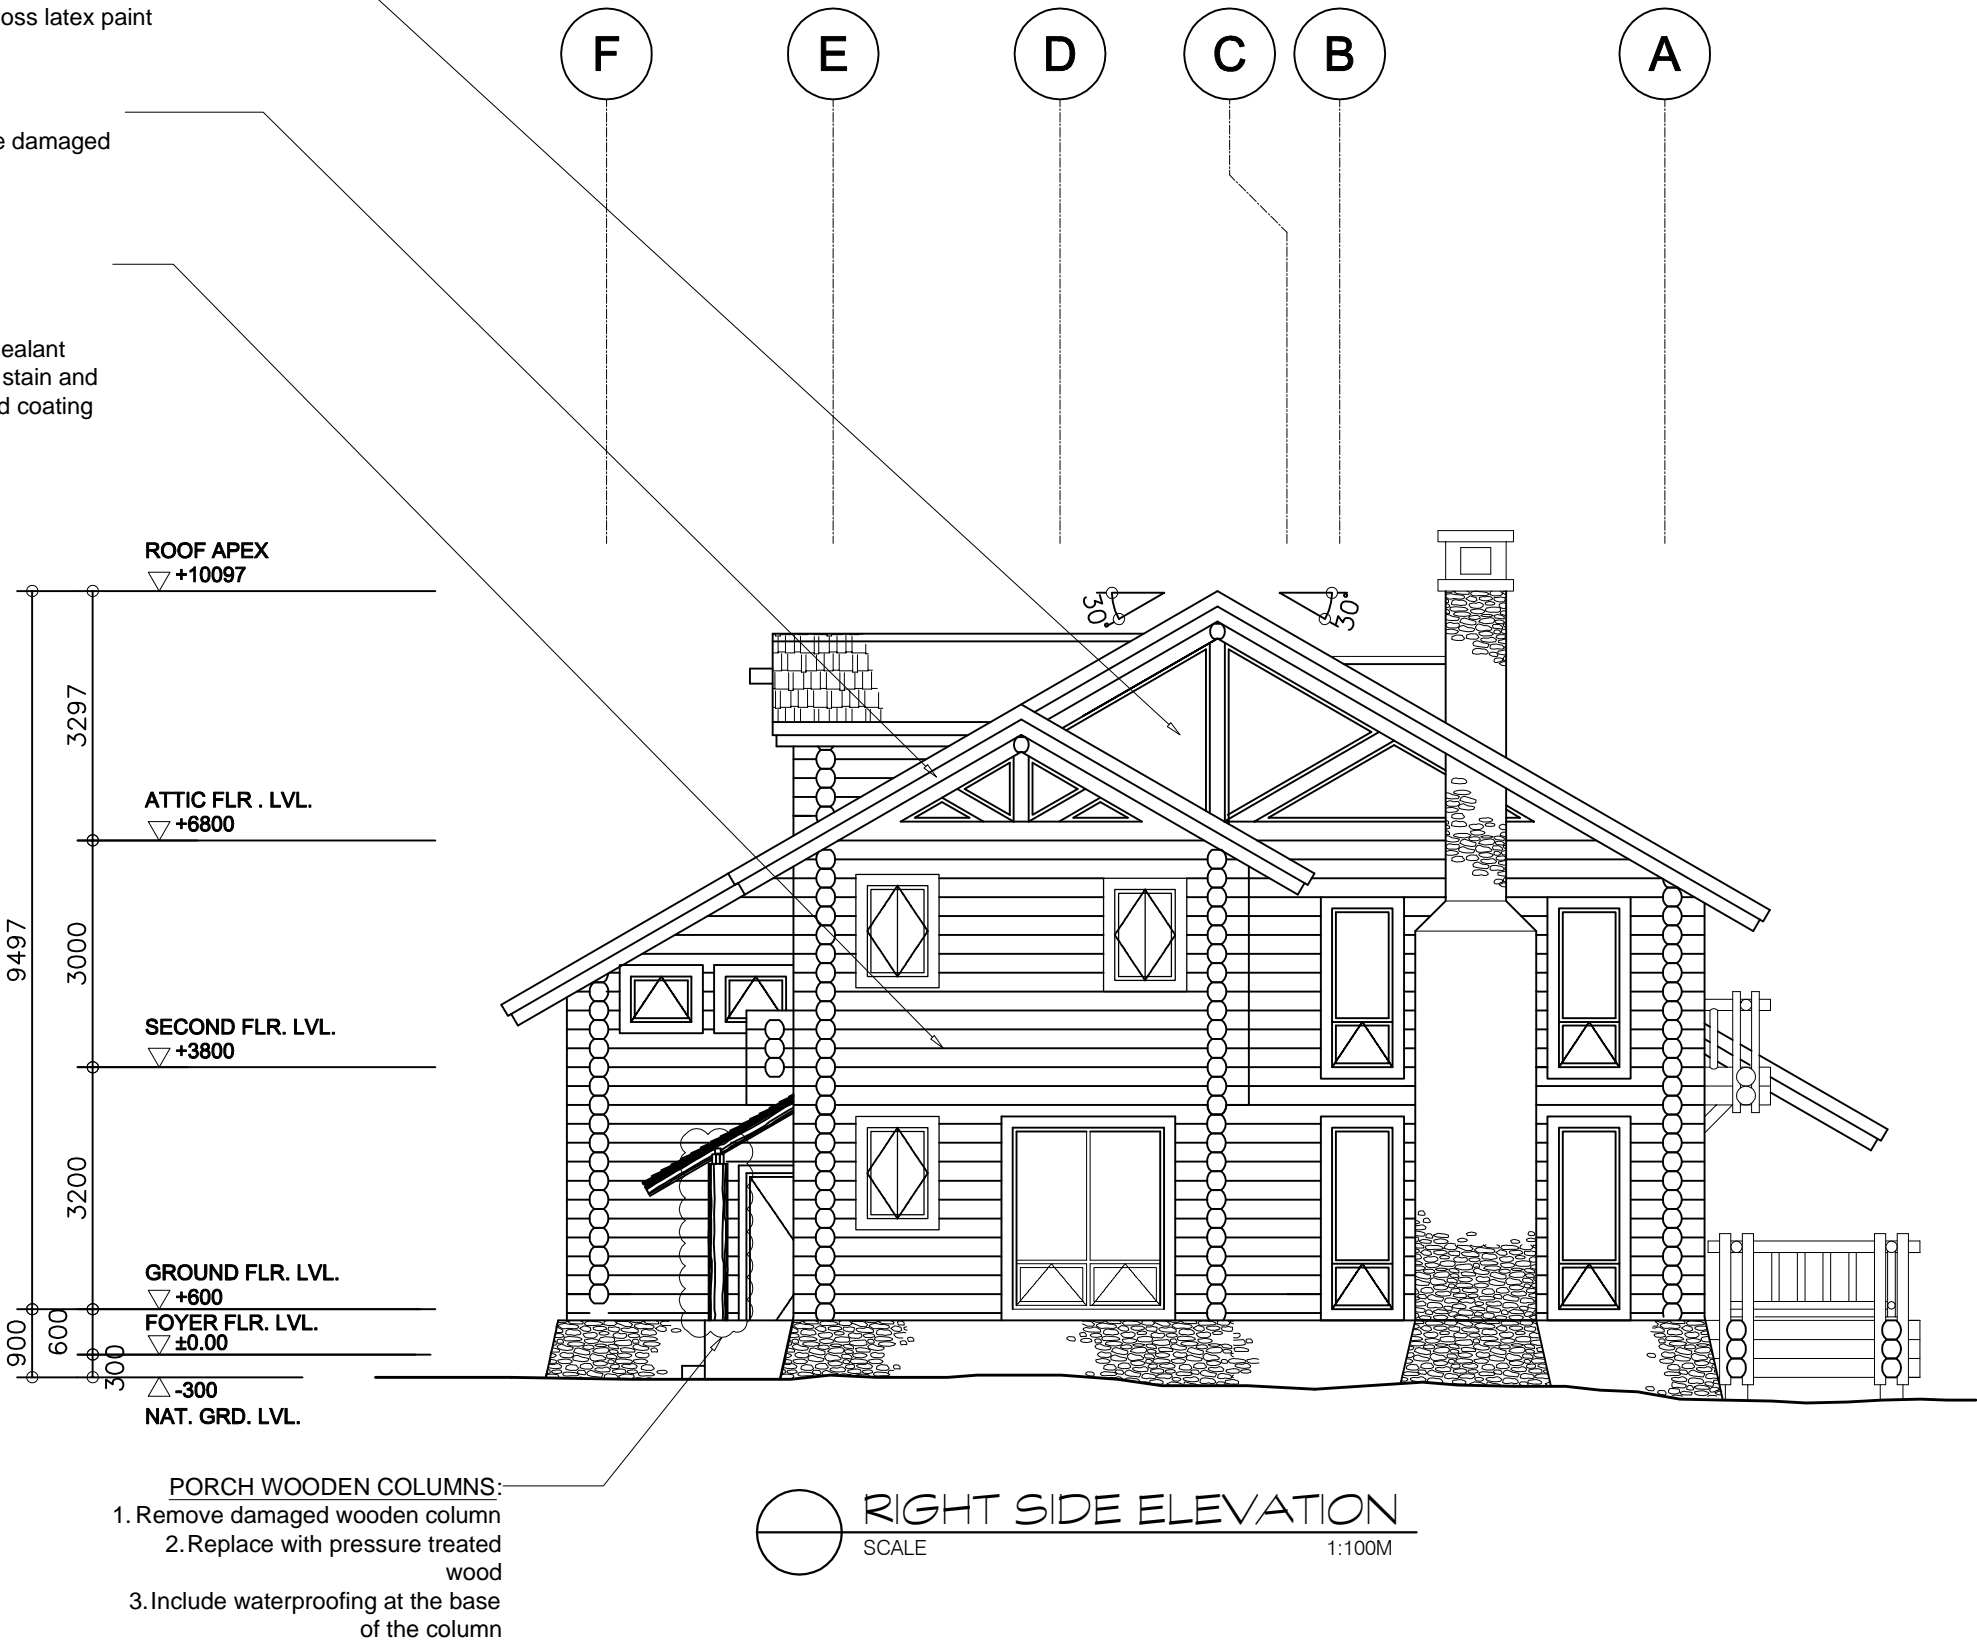
- CEMENT BOARD:
- 1. Cleaning
  - 2. Sanding
  - 3. Paint with semi-gloss latex paint

- FASCIA:
- 1. Remove and replace damaged fascia

- HALF LOG SIDINGS:
- 1. Cleaning
  - 2. Sanding
  - 3. Application of joint sealant
  - 4. Application of wood stain and acrylic solvent-based coating
